ERDC/GSL TR-03-7

Enhanced Coastal Trafficability: Road Construction Over Sandy Soils

July 2003

Final report

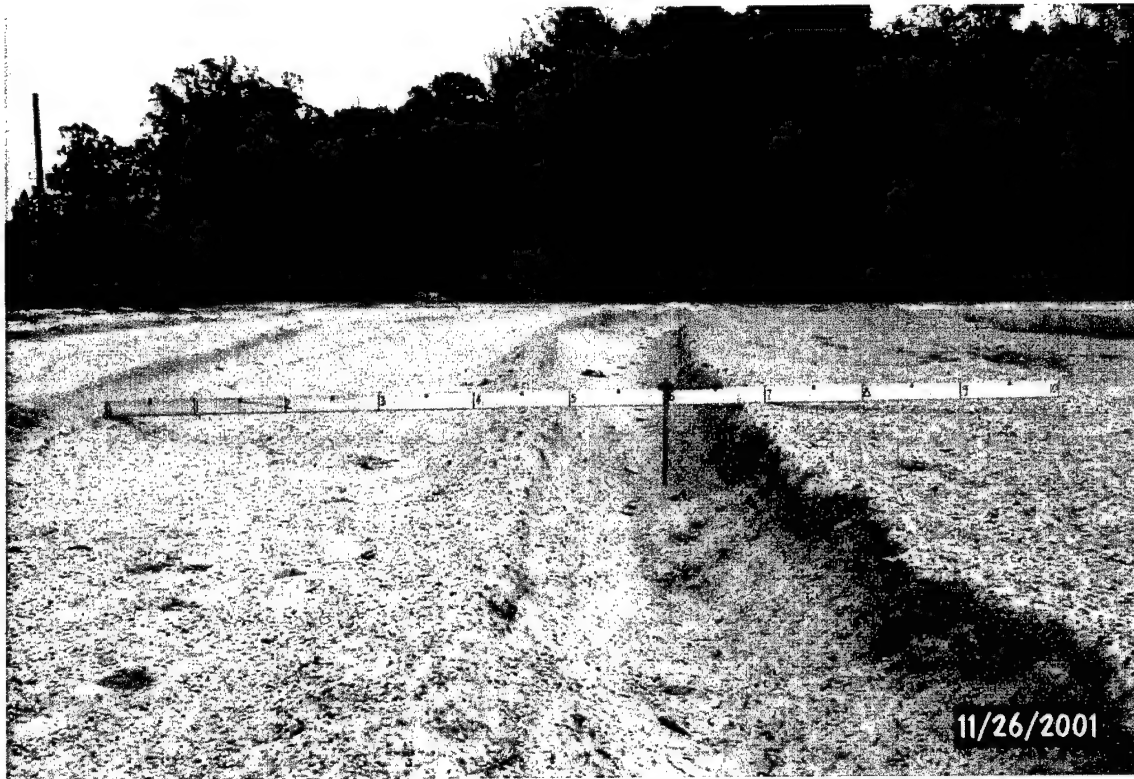
Photo 21. Loose sand layer after 10 passes of 5-ton military truck

The test section was constructed and evaluated during the period June through December 2001. All construction work was accomplished by ERDC personnel using conventional construction equipment. Items 1 through 3 were arranged in an oval configuration so continuous truck traffic could be applied over the items. The existing dredge material (ML soil) had an average CBR of 9 percent. The existing material was not disturbed, but two sections at the edge of the gravel-surfaced road were cut to fit the oval section with the boundary conditions (Photos 13 and 14). At the outside and inside edge of shoulders, flags and strings lines were placed. The flags were placed every 5 ft. Over the existing dredge material, 12- to 28-in. sand layer was delivered by dump truck and leveled with a D4 bulldozer (Photos 15 through 17). The difference in the sand layer thickness was to overcome the irregular topographic ground contour (Figure 14). To replicate the loose conditions of beach sand, the 36-ft- wide sandy base course layer was not compacted. Two pipes were placed in the sandy base's toe so that the water level could flow naturally within all experiment areas (Photos 18 and 19). An aerial view of the experiment site prior to items installation is shown in Photo 20. Figure 14 shows the elevations and field test section location. The roadway's loose sand condition was demonstrated by a 5-ton military truck loaded to 41,600 lb becoming immobilized after 25 passes. Photos 21 and 22 show the 10-in. rut depth after 25 passes of the 5-ton military truck.

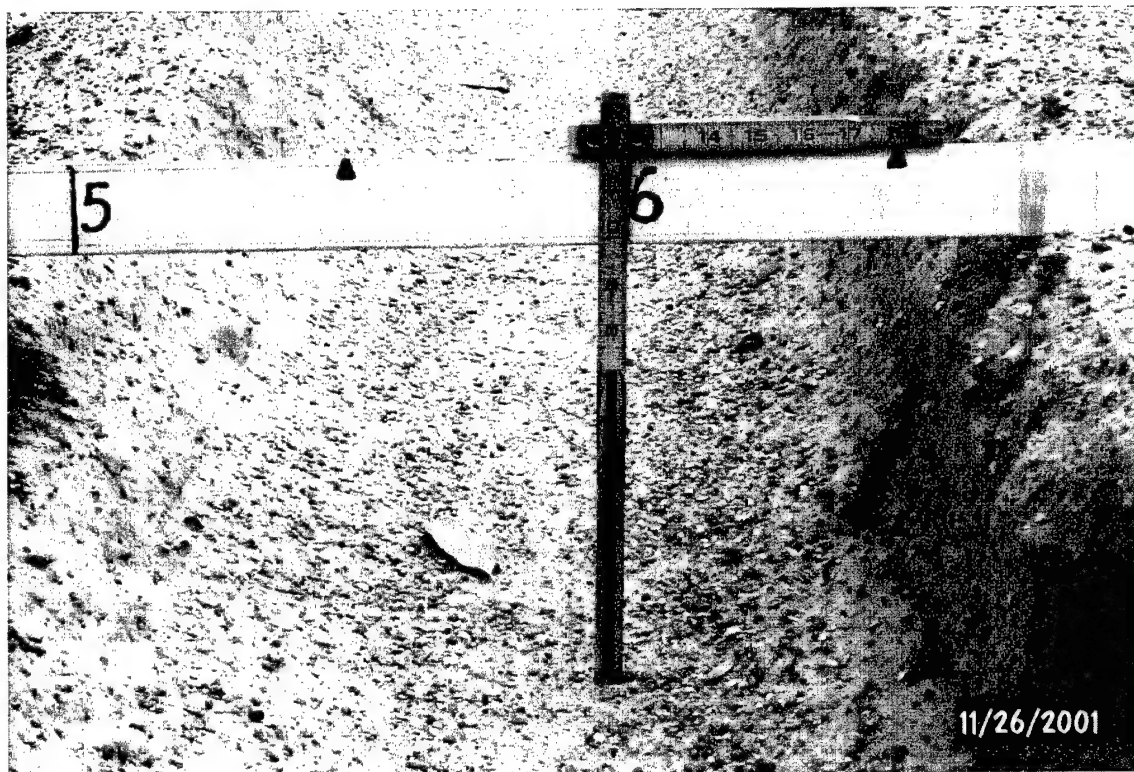
Photo 22. Close up 10 in. rut depth after 10 passes of 5-ton military truck

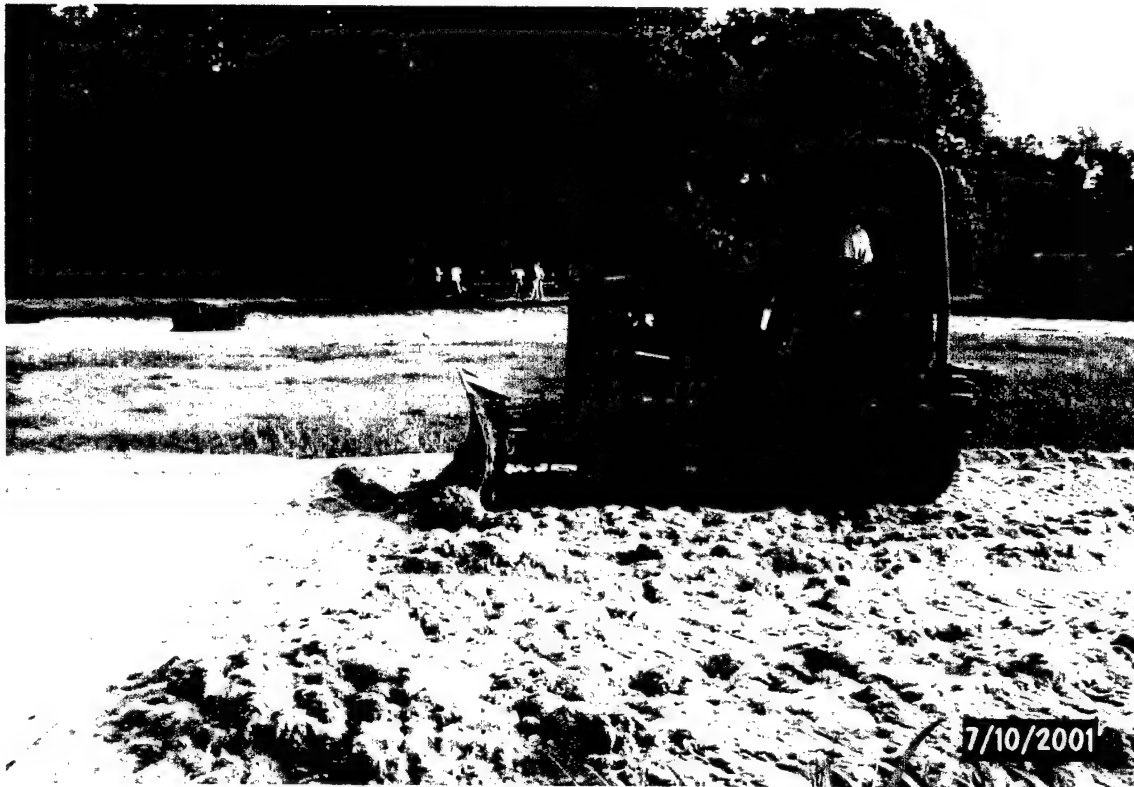
Photo 71. D4 dozer leveling/smoothing the sand-geofiber sections

After the mixing process, a D4 dozer was used to level/smooth the sand-geofiber (Photo 71). Due to high temperatures and evaporation of the sand-geofiber moisture, water was sprayed using a water truck hose (Photo 72). Water was added to the Item 3 for about 25 min. After the watering process, the sand-geofiber layer was compacted with five coverages (5 passes = 1 coverage) with the smooth drum vibratory compactor to form an 8-in.-thick base layer (Photo 73). The outside and inside edges of the lane were compacted first, followed by the inner section of the lane. Several areas in the sand-geofiber item depressed after compaction was completed. These areas were patched after the Road Oyl application.

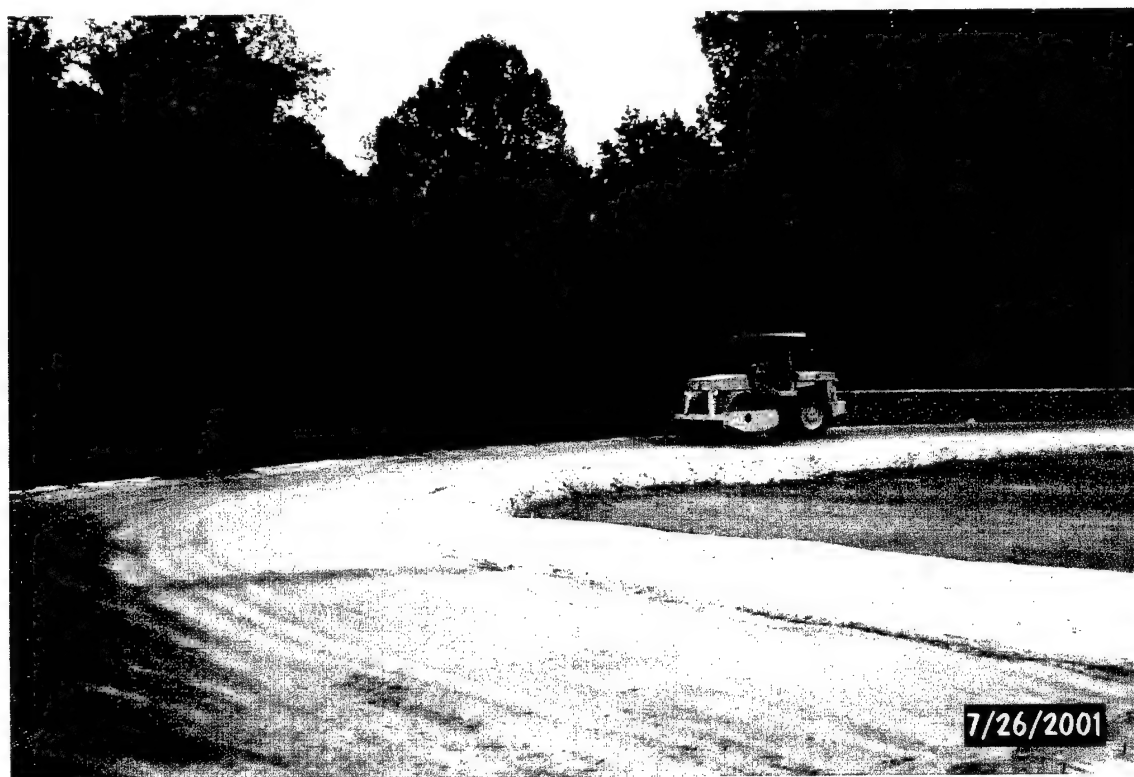
Photo 78. Compaction to seal the sand-geofiber surface

Finally, four passes of the vibratory steel-wheel roller were applied to seal the surface (Photo 78). The outside and inside edges of the lane were compacted first, then the center section of the lane. In the patched areas, the sand-geofiber peeled off with compaction due to the adhesion of the Road Oyl. Several lessons were learned during the patching of the sand-geofiber item. First, the depressed areas need scarification before placing the patching sand-geofiber material. Second, Road Oyl should be mixed into the sand-geofiber mix to be used for repairs. Finally, the steel-wheel roller should be used but without vibration.

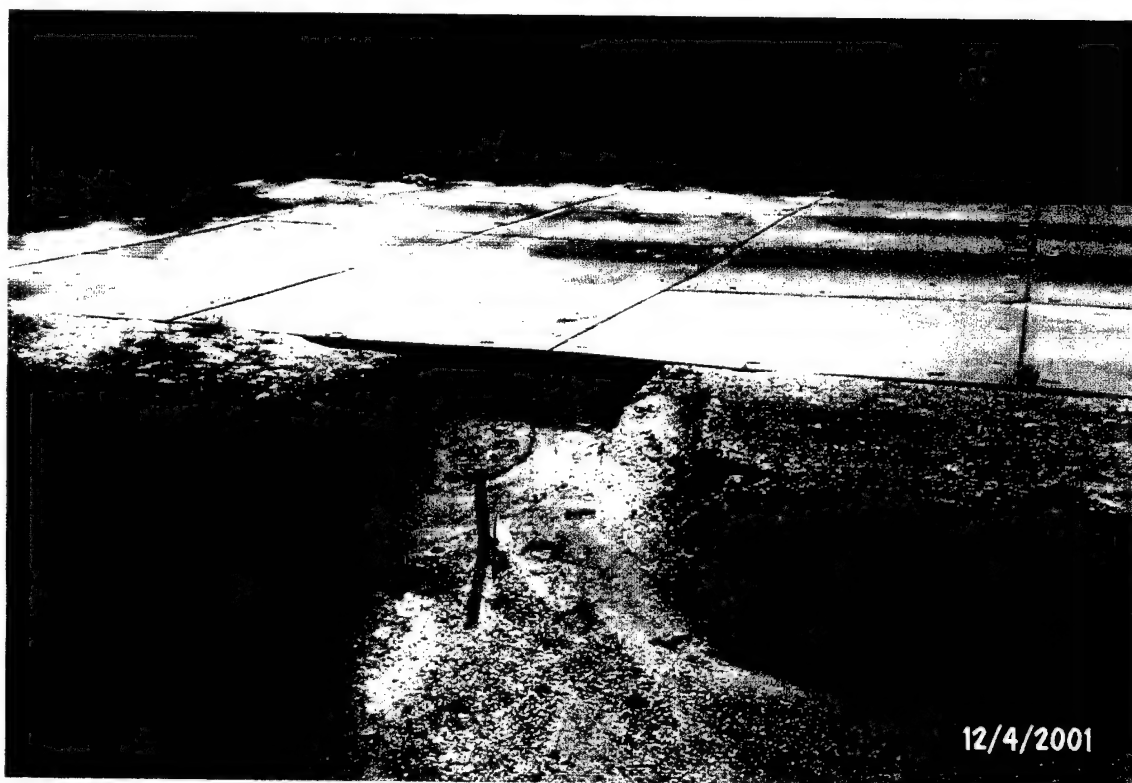
Photo 80. Shoulder's erosion due to heavy rains

No maintenance was performed on Item 1 (MP mats) with the exception of the sand shoulders. The inside shoulder of the MP mat item was eroded due to heavy rains (Photo 80). The eroded shoulder was repaired with sand-geofiber mix (Photo 81). After 25 passes on Item 2, 2- to 3-in. ruts were measured in the Allround hexagonal plastic mats section and 1-in. ruts had developed in the Special hexagonal plastic mat section. After 165 passes, the Allround hexagonal plastic mats were removed due to the severe rutting (4 in.) and disconnection of mats. Once the Allround hexagonal plastic mats were removed, the top 6 in. of the sand layer was pushed from the outside edges to the inside of the section using a D4 dozer. The sand layer was then re-leveled, and a 6-in.-thick layer of crushed limestone (about 100 tons) was placed on top of the sand. The crushed limestone was wet and contaminated with fines. A front-end loader was used to place the crushed limestone in a 20-ft-wide center section of the roadway. The spreading of the limestone started at the edge of the MP mat item and worked toward the Special hexagonal plastic mat section. After the limestone was placed and spread, it was compacted with 3 coverages of a vibratory steel-wheel roller. After 300 truck passes, the wheel path area in the transition between Special hexagonal mat and 75-ft radius curve section of the sand-geofiber item developed rut depth of 3 in. The deterioration of the transition was filled with geofiber-stabilized material from stockpiles (Photo 82). During the traffic period, the outside and inside shoulders of the entire oval field test section were eroded several times due heavy rains. In all case, they were repaired using sand-geofiber.

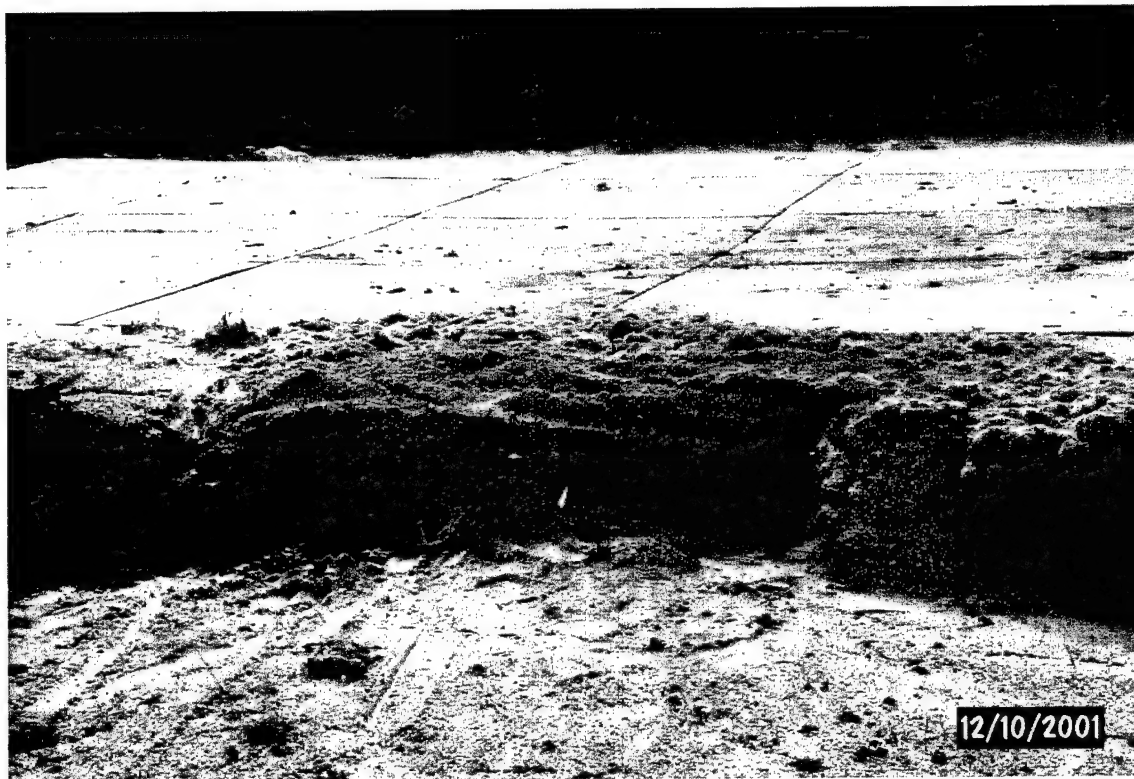
Photo 81. Repair shoulder with sand-geofiber

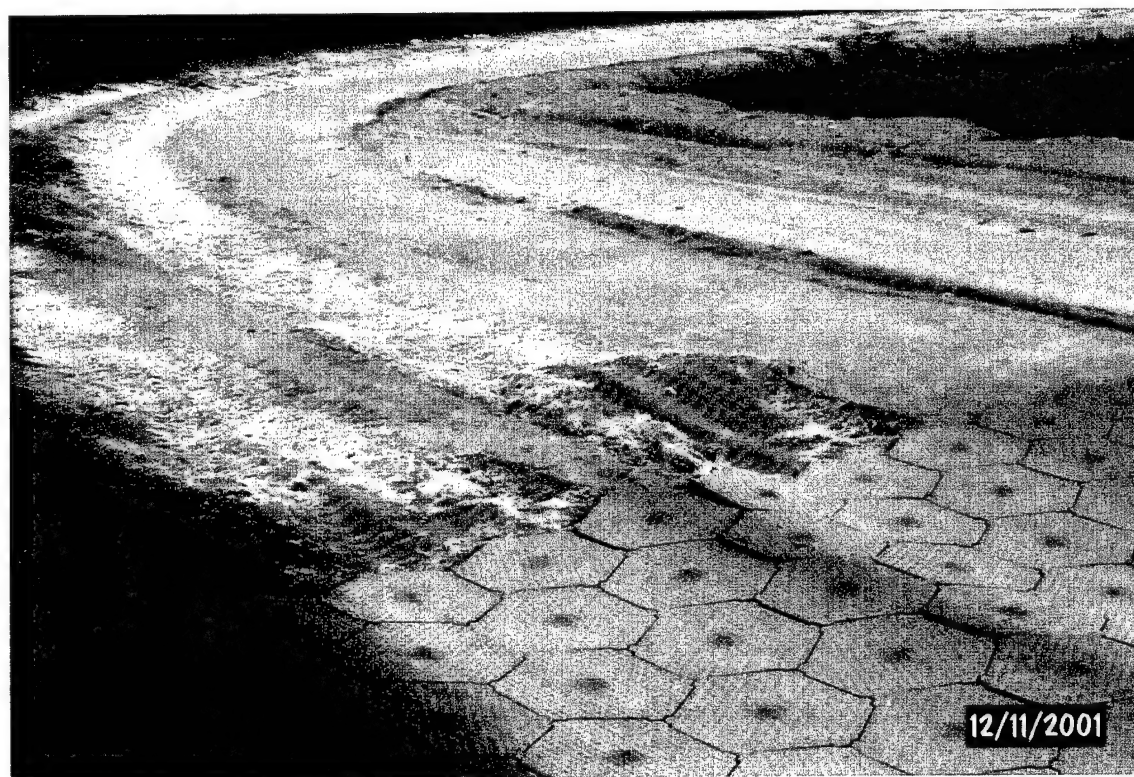
Photo 82. Deterioration in the transition zone

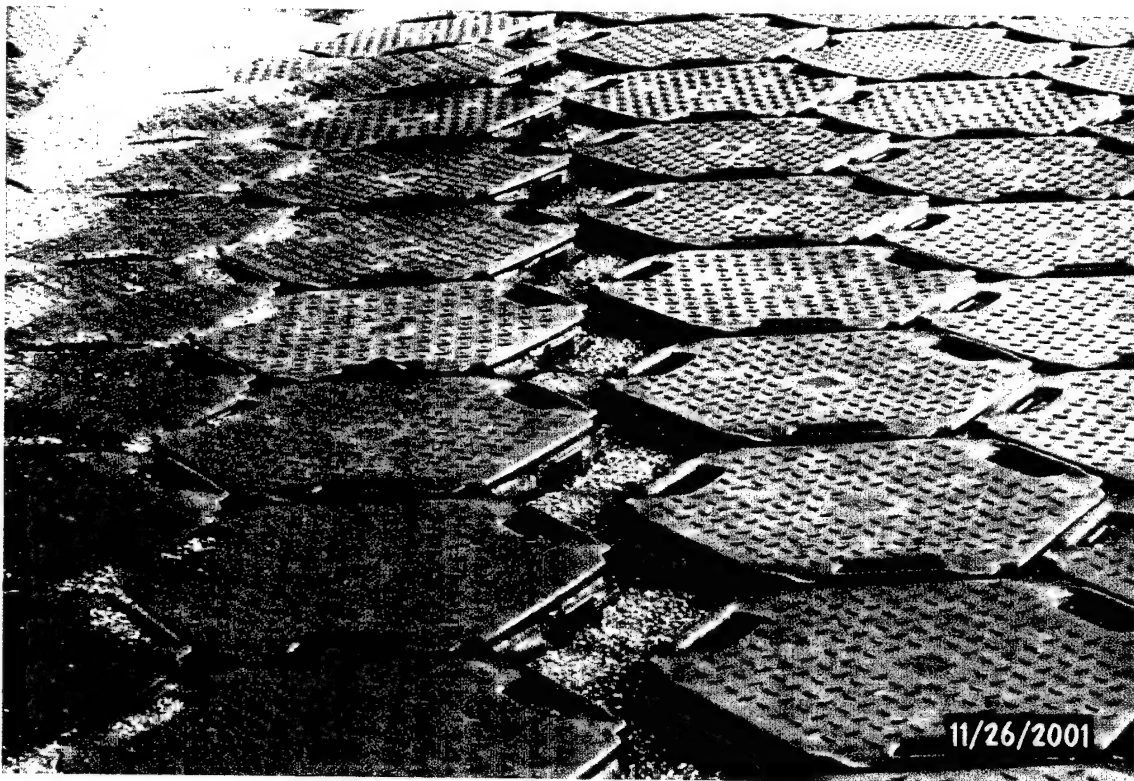
Photo 84. Allround hexagonal mat unzipped after 165 passes

Allround hexagonal plastic mat section. The Allround hexagonal plastic mats section had an outside and inside radius of 74-ft and 50-ft, respectively. These mats were previously tested on straight sections and performed excellent. The performance of this mat under 50-ft radius curves was poor as indicated by 2.49 in. average permanent deformation after 165 truck passes. The maximum permanent deformation was 12 in., therefore, the traffic was discontinued and item was replaced. The mats were removed since the mats were hitting the truck's axles. Forty-two mats were damaged as shown Photos 90 and 91. The mats disconnected at the upheaval and center lane areas. The poor bearing capacity of the loose sand, shear forces caused by truck tires, and poor mat connection mechanisms unzipped the mats in these areas (Photo 92). To maintain trafficability of the field test section, the Allround hexagonal mat section was replaced with a 6 in. layer of crushed limestone.

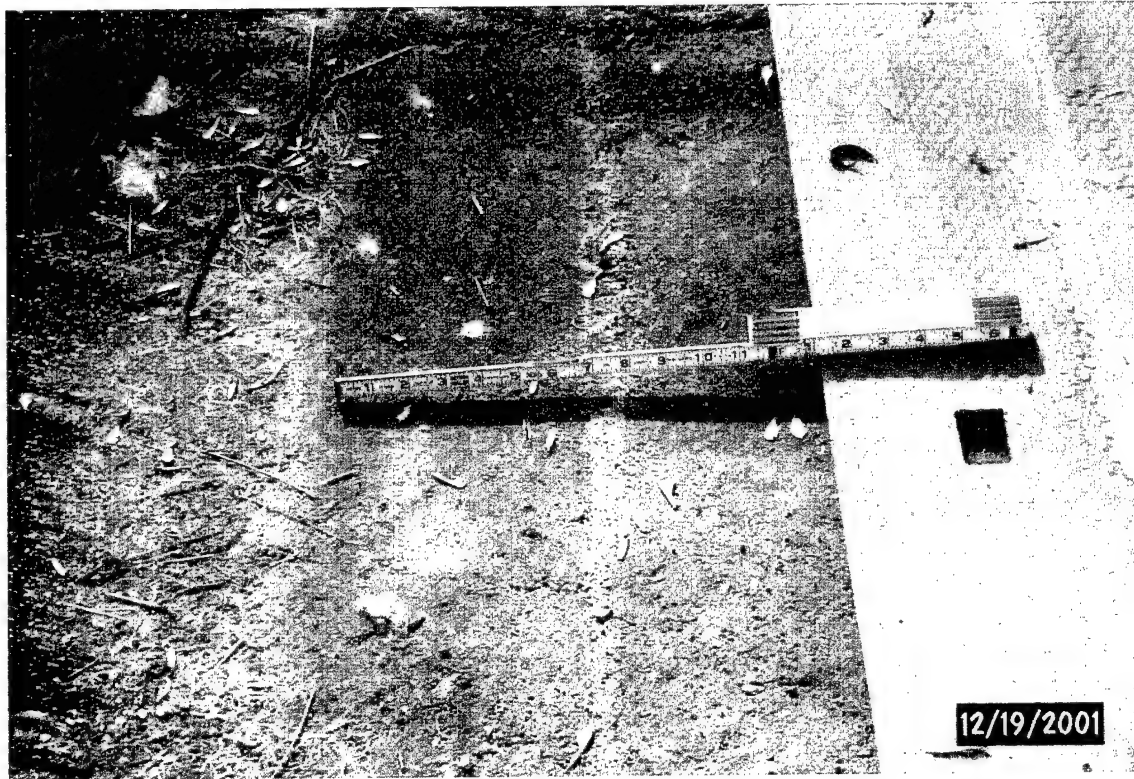
Photo 85. MP mat straight section moved 1 ft toward traffic direction after 500 passes

Straight section. This section reached an average permanent deformation of 1.28 in. after 500 truck passes. The mat and connector pins performed well. One panel was slightly damaged, and one pin was loose. After 300 truck passes, the section moved about 8 in toward traffic direction. Photo 85 shows a total displacement of 12 in. on the straight section after 500 truck passes. One connector pin was not properly tightened and became disconnected after 500 passes (Photo 86). One MP mat delaminated at the downward fold edge as shown Photo 87. The anchor performed well once it locked itself as shown in Photo 88.

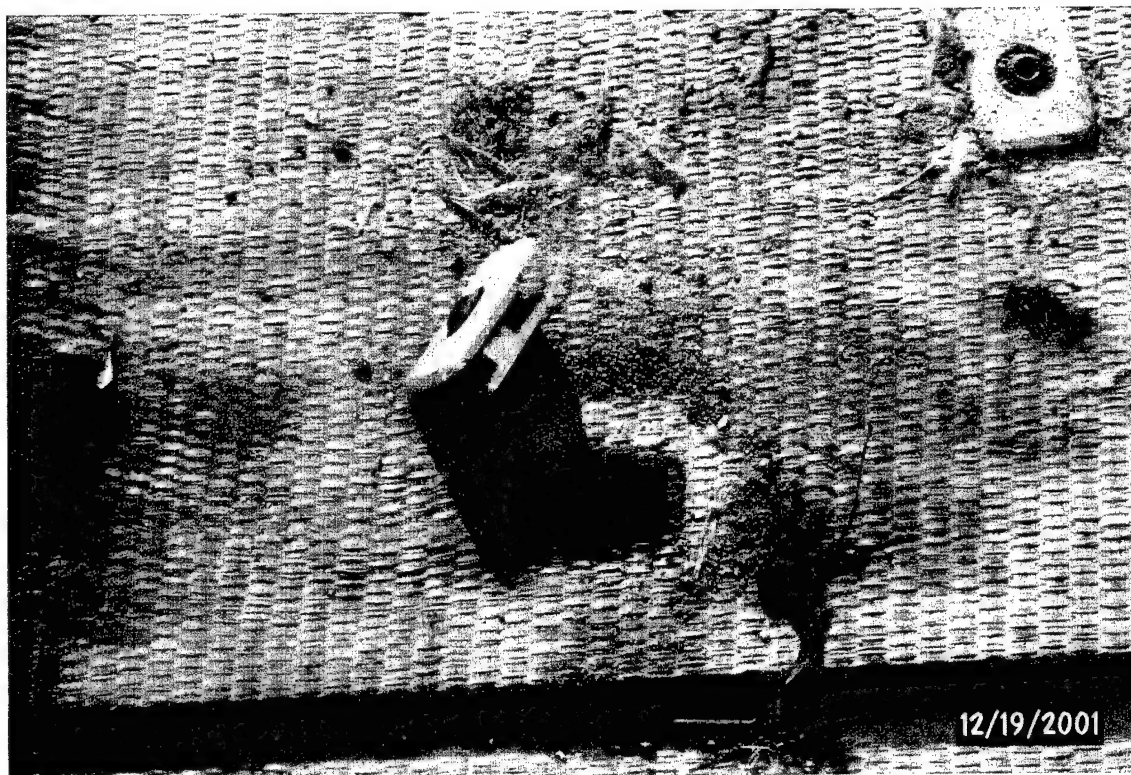
Photo 86. MP mat straight section connector pin loose after 500 passes

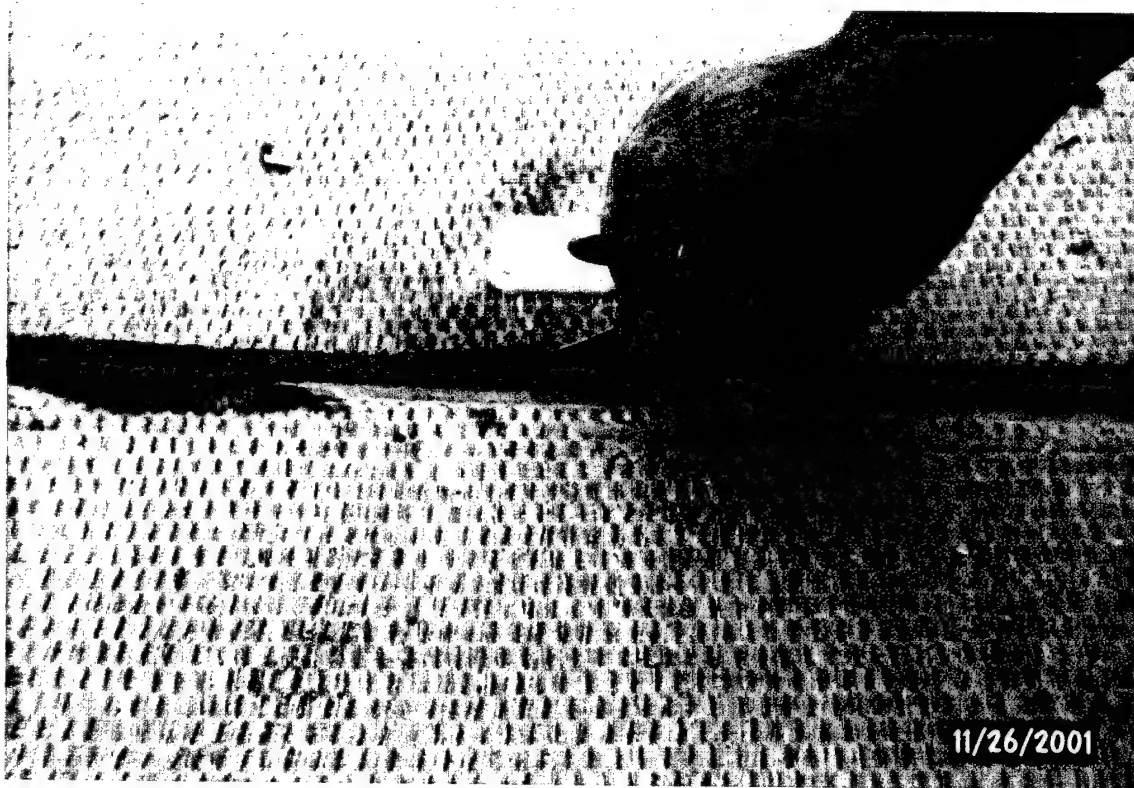
Photo 87. MP mat straight section edge delamination after 165 passes

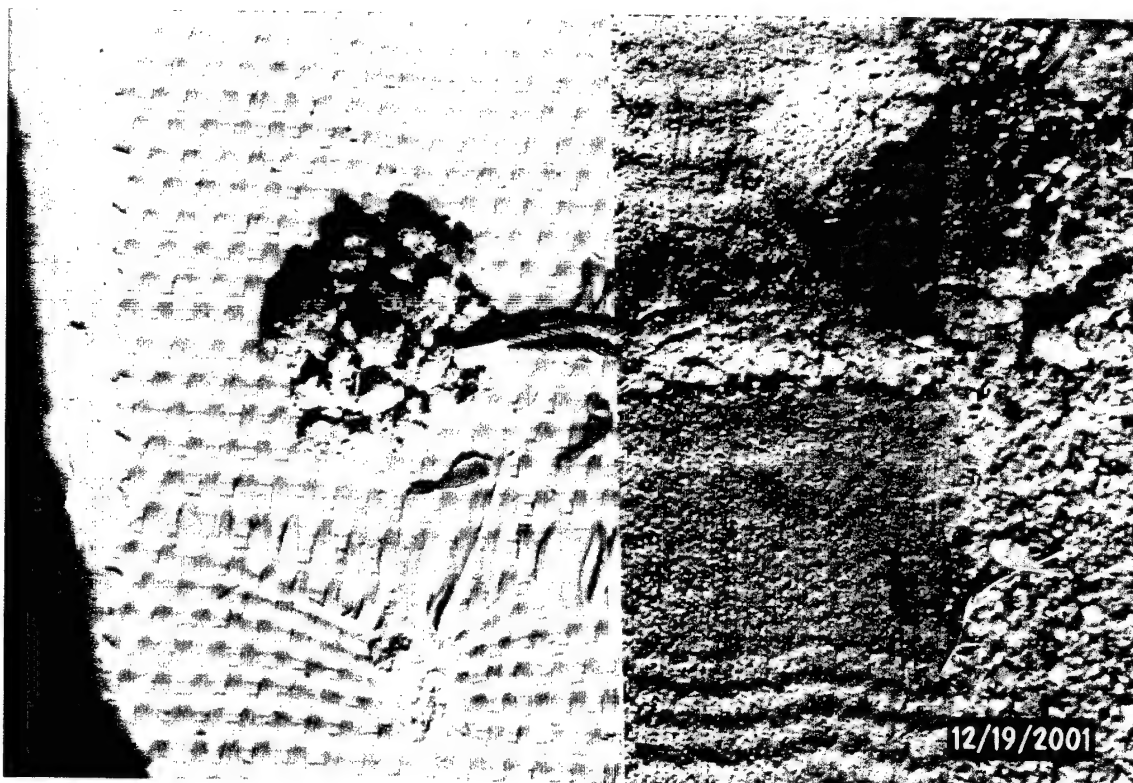
Photo 88. MP mat anchor after stretching the cable after 165 passes

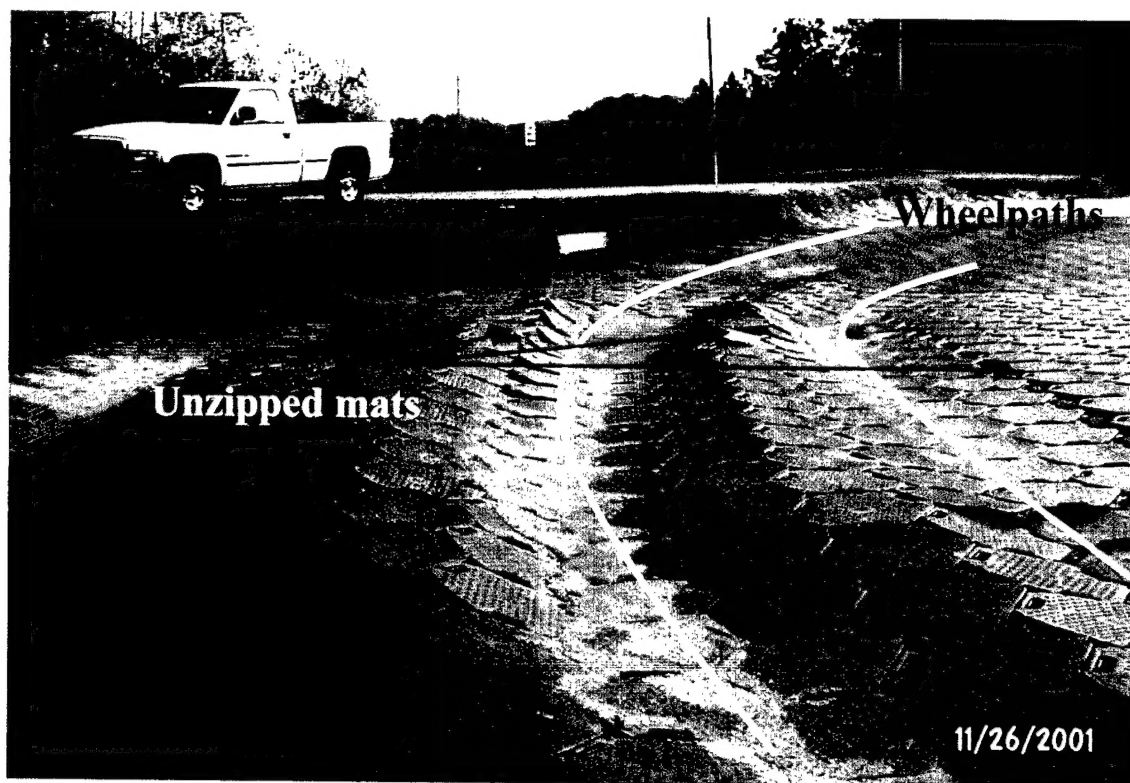
Photo 92. Allround hexagonal mat unzipped after 165 passes
